Earthquake Damage to Fill Dams in Japan

Shigeru TANI

Department of Structural Engineering, National Research Institute of Agricultural Engineering (Tsukuba, Ibaraki, 305-8609, Japan)

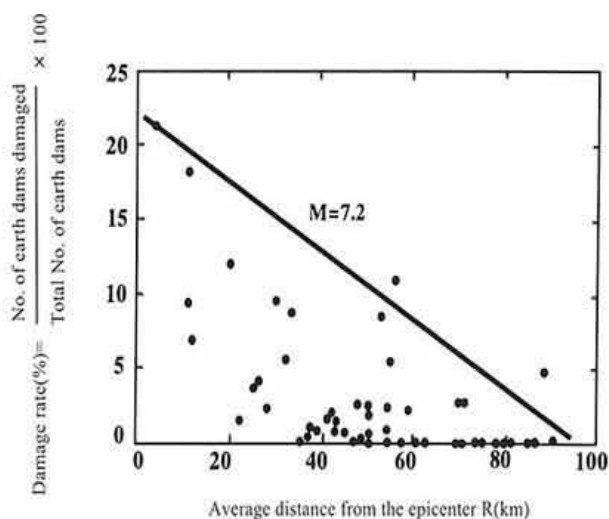
Fig. 2. Average epicenter distance and damage rate of earth dams in the case of Hyogoken Nambu earthquake

Fig. 2 shows the relationship between the damage rate of earth dams and the average distance from the epicenter of the affected districts in the case of Hyogoken Nambu earthquake. The solid line in the Figure represents the maximum value for the relationship between the damage rate and distance from the epicenter. Although this relationship differs depending on the conditions of the ground and dam bodies, the line in the Figure represents the maximum values of the distance from the epicenter and the reservoir damage rate, which was attributable to the earthquake.

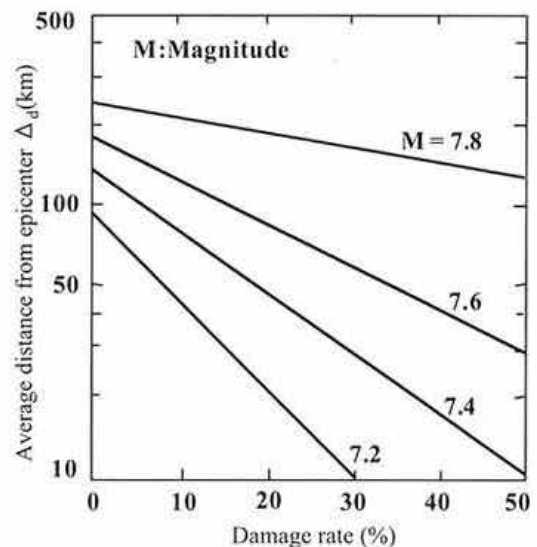
Fig. 3. Relationship between average distance from epicenter and damage rate based on past earthquake data

Fig. 3 depicts the relationship between the average distance from the epicenter and estimated maximum damage rate as a function of the magnitude for the Tokachi-oki, Niigata, Nihonkai Chubu, and Hyogoken Nambu earthquakes shown in Table 1. Since the degree of damage and ground and dam conditions were not taken into account, the estimates are merely conservative.

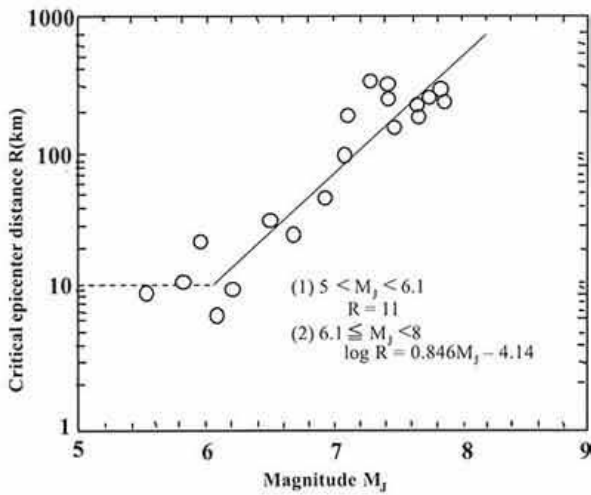
Fig. 4. Relationship between magnitude M_j and critical distance from epicenter R

Fig. 4 shows the relationship between the earthquake magnitude (M_J) and the earth dam farthest from the epicenter, which was damaged by the earthquake

(hereafter referred to as “critical distance from epicenter”). Using past data, the relationship between M_j and the critical distance from the epicenter can be expressed as:

$$R = 11 \quad 5 < M_j < 6.1 \dots\dots\dots(1)$$

$$\log R = 0.846 M_j - 4.14 \quad 6.1 \leq M_j < 8 \dots\dots\dots(2)$$

where M_j : magnitude, R : critical distance from epicenter (km).

This relationship is indicated by the solid line in the Figure, which also delineates the boundary of the damaged area. The upper area did not sustain any damage and the lower area shows the zone where damage is likely to have occurred. Therefore, the damage rate increased in a downward direction in the Figure. It should be noted that the critical distance from the epicenter represents the distance from the epicenter shown in Fig. 4 at which the damage rate became zero. The value of Equation (1) depends on the properties of the earthquake, ground con-

ditions, and earth dam conditions. However, the approximate distance from the epicenter at which damage starts to occur can be determined by calculating the distance from the epicenter and the magnitude.

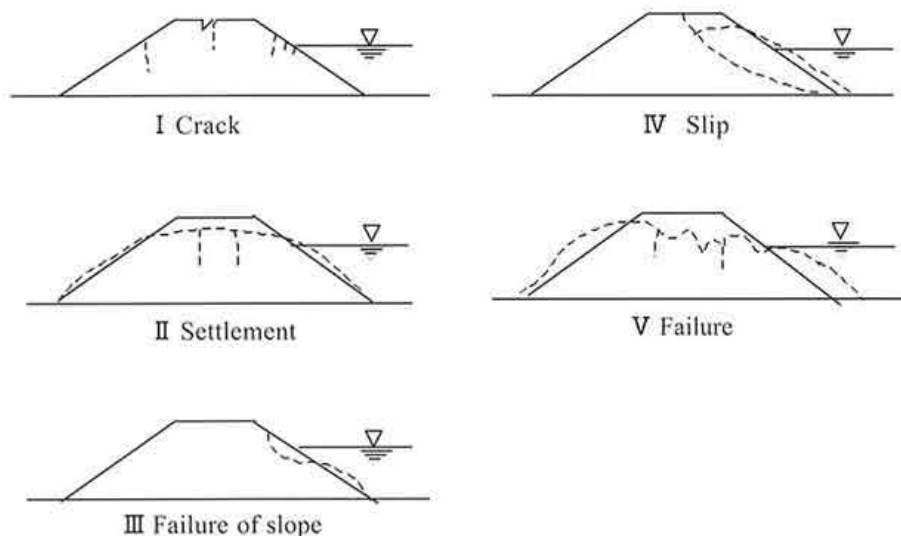
Fig. 5. Classification of damage types

For grouping the type of damage in Nihonkai Chubu earthquake, a classification was carried out on the basis of the major causes of damage, according to the damage classification for river dikes and railway embankments. Fig. 5 shows the classification of damage types. Table 3 shows the types of damage. Types I and III accounted for

30% respectively, followed by Types II, IV and other types. Type V accounted for only 1.8%. In Type I (crack) the shape of the dam body was maintained with little settlement and cracks alone were generated. This

type is characterized by the fact that many dam bodies are made of clay on good foundation ground. There were 3 examples of cracks generated along the line grouted in the past. In Type II (settlement) the shape of the dam body was maintained with accompanying cracks, and the major cause was attributed to the settlement of the foundation ground. Type III (failure of slope) and Type IV (slip) showed basically the same type of damage, but in Type III the damage was less severe than in Type IV. Most of the dam body remained sound and serious damage was not observed in Type III. A slip was recognized in Type IV, though this type accounted for only a few cases. Most part of the dam body experienced settlement by slip in Type IV, frequently causing large damage such as failure. In Type V, the dam body and the foundation ground were broken. Though the number of cases was very low, earth dam failure occurred in many cases like in Type III. The estimated causes included liquefaction of the dam body and foundation ground. In addition, outlet works, spillway, abutment break, and damage to only the covering block accounted for about 10% of the total.
