Prediction of Inundation Areas Due to Failure in Small Earthfill Dam Using Numerical Analysis

Daisuke SHODA*, Osamu KAWAMOTO, Hiroshi YOSHISAKO and Keisuke INOUE

Facilities and Geotechnical Engineering Research Division, National Institute for Rural Engineering, National Agriculture and Food Research Organization (NARO) (Tsukuba, Ibaraki 305-8609, Japan)

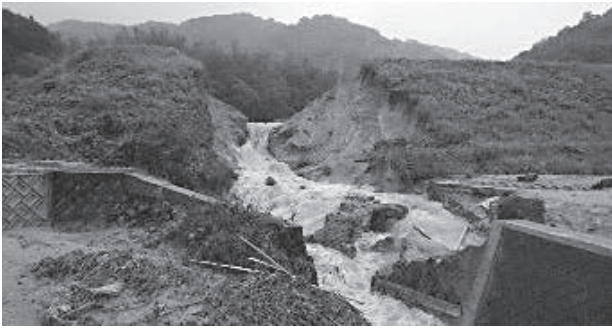
Fig. 1. Dam failure

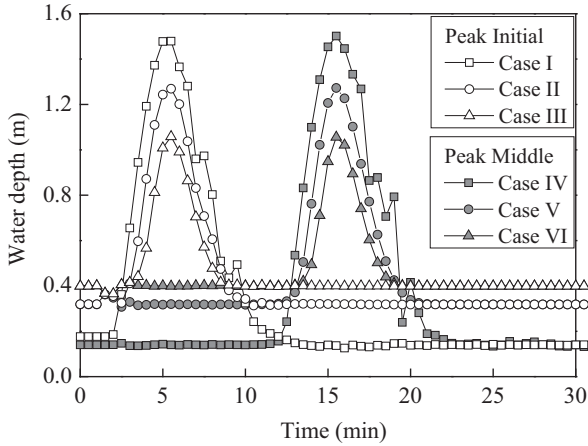
The water depth at a point 550 m from the outflow, as shown in Fig. 3, is the distance from the damaged house to the failed A-dam shown in Table 1. The water depth shape is equivalent to the outflow shape regardless of the gradient of the dam downstream site. This indicates that the downstream water depth is extremely sensitive to changes in outflow distribution.

Fig. 3. Variations in water depth at point of damaged house

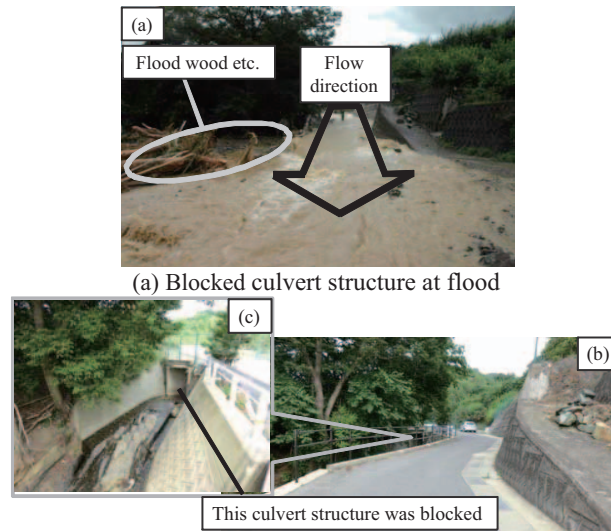
Fig. 4. Culvert structure located downstream of earthfill dam

vert structure downstream appears to be blocked by flood debris (wood or mud and sand). The results using normal elevation were invalid because the blocked culvert structure was not simulated. The proposed method for this simulation is described later.

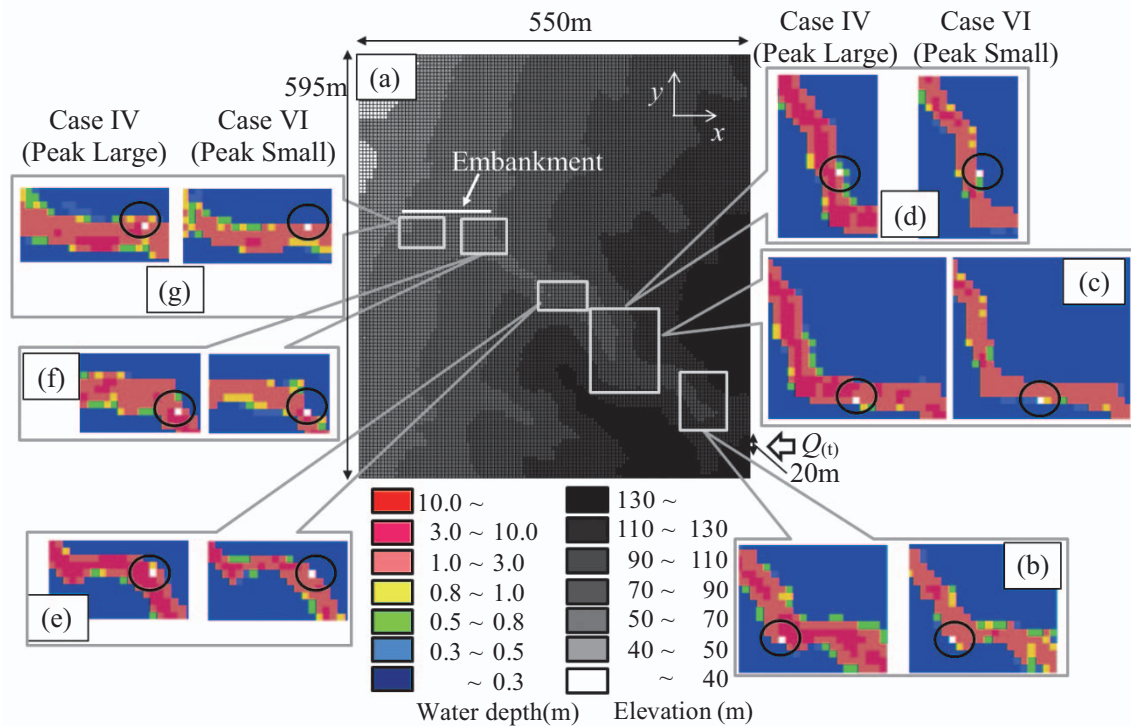
Fig. 5. Contour map of elevation in analytical region and maximum water depth (Left side is Case IV, right side is Case VI (outflow pattern, see Table 2))

Contour maps of the elevation and maximum water depth at each section are shown in Figs. 5 (a) and (b)-(g). The dam failure point is shown at the bottom right of Fig. 5 (a). The white mesh circled with a black line in Figs. 5 (b)-(g) shows the same position for Cases VI and IV. At the center of the flow path, the water depth in Case IV is deeper than that in Case VI in Fig. 5 (b)-(g). The width of the flow path shown in Case IV is also slightly wider than that shown in Case VI. The embankment shown in Figs. 5 (f) and (g) exists in *x*-direction, and the outflow was not over the embankment, which matches the field-survey results.

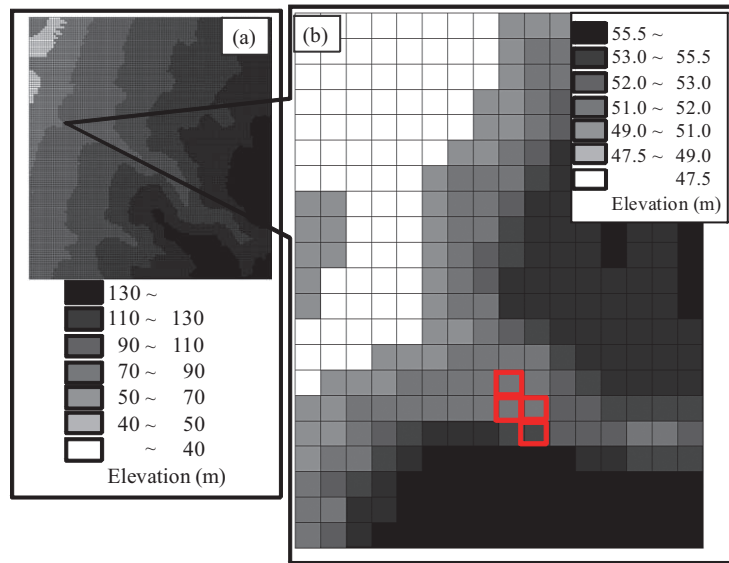
the culvert structure rises 3 m from the original elevation. The height of the culvert structure was 3 m. Fig. 6 shows a contour map of the elevation in the analytical region and a contour map around the culvert structure with the change in elevation. The four meshes with elevation change are indicated in Fig. 6 (b).

Fig. 6. (a) Contour map of elevation in analytical region (b) Contour map of elevation around culvert structure with change in elevation

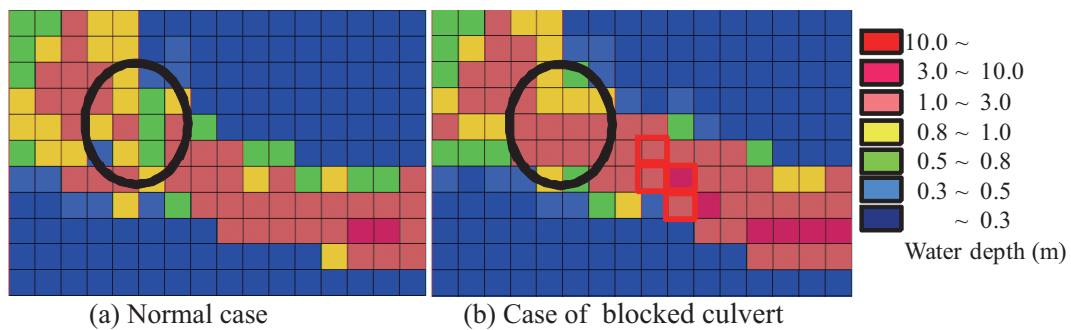
Fig. 7 shows the maximum water depth around the culvert structure with the change in elevation. The four meshes with red frames in Fig. 7 (b) indicate the locations of elevation change. Comparing Figs. 7 (a) and (b), the latter shows a water depth of about 3 m at the downstream site (circled in black) of the blocked culvert structure. In Fig. 7 (a), the depth is lower than 3 m in the section circled in black. Evidence of inundation area for the field survey was confirmed at a water depth of about 3 m around the culvert structure. The analytical results based on changes in elevation matched the field-survey results.

Fig. 7. Maximum water depth around culvert structure with change in elevation
