Developing a Salt-Removal Plan to Remedy Tsunami-caused Salinity Damage to Farmlands: Case Study for an Area in Southern Thailand

Tetsuo NAKAYA*, Hajime TANJI, Hirohide KIRI and Hiromasa HAMADA

Department of Geotechnical and Hydraulic Engineering, National Institute for Rural Engineering,
National Agriculture and Food Research Organization (Tsukuba, Ibaraki 305–8602, Japan)

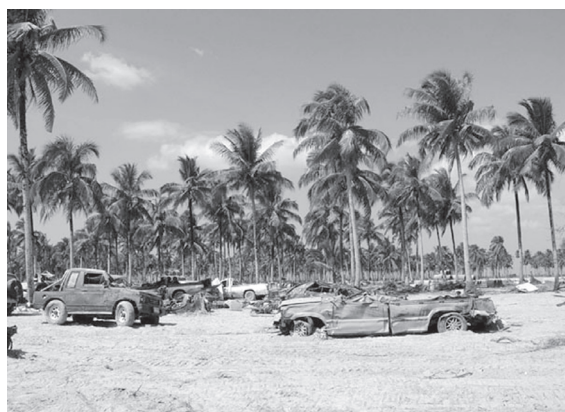
Fig. 1. An illustration of the damage to farmland in southern Thailand that was observed immediately after the 2004 tsunamis

The tsunamis caused by the earthquakes that occurred west of Sumatra on 26 December 2004 brought disaster to Thailand, particularly in the southern coastal areas of Phang Nga Prefecture, leaving 5,000 people dead and 3,000 people missing. When a tsunami occurs, tourist resorts and the social infrastructure are generally reconstructed quickly, but almost no activities are carried out to investigate and remedy salt damage to farmland. Because the damage to agriculture only appears to affect crops, public interest in this damage is less than the interest in more obvious human losses. However, because most people in the stricken area earn their livelihood by farming, it is crucial to monitor this damage and to perform restoration work in some areas. Figure 1 illustrates the damage to farmland in southern Thailand.

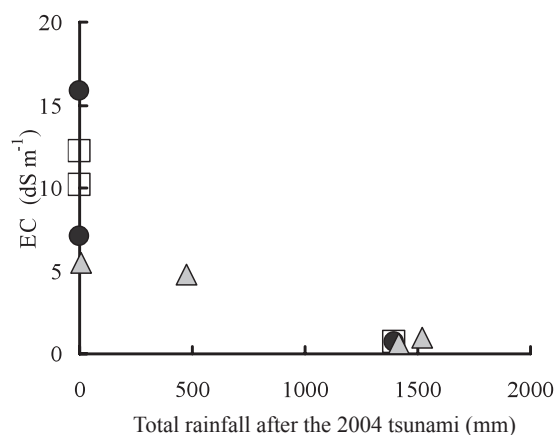
**Fig. 5. The relationship between the total amount of rainfall after the 2004 tsunamis and electrical conductivity (EC, 1:5 soil to water) of the soil**

● : Bang Niang, □ : Nam Khem, △ : Pa Lai.

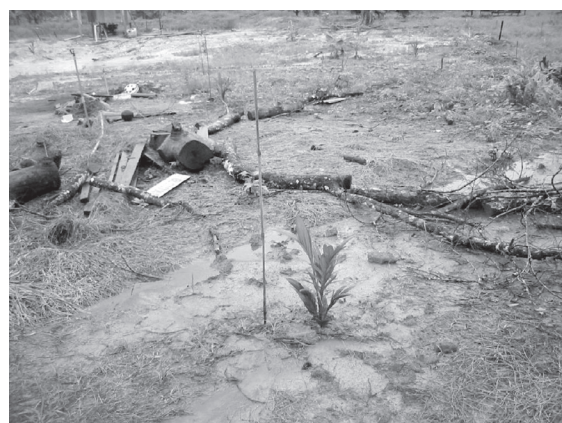
**Fig. 6. At Bang Niang, dying rambutan trees were removed and oil palms were planted 6 months after the 2004 tsunamis**

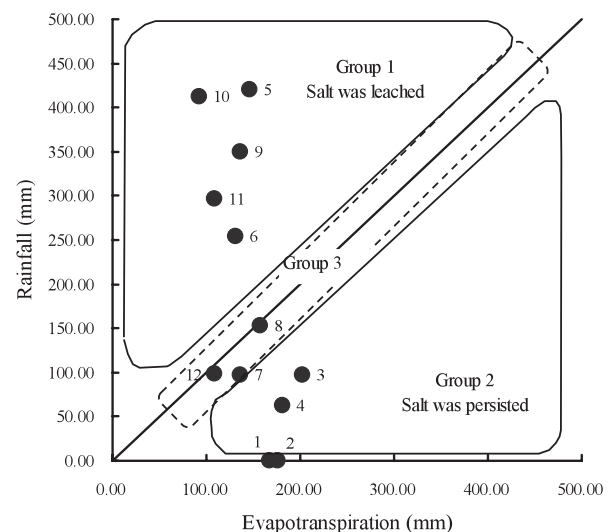
Fig. 8. A simple grouping of the results (numbers refer to the month numbers in Fig. 7) of the water-balance calculations to show annual trends

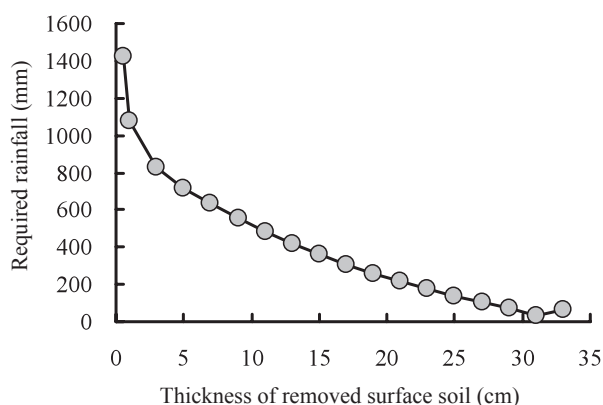
Fig. 9. The relationship between the thickness of surface soil that must be removed and the amount of rainfall required for salt removal

We calculated the amount of water required to remove this quantity of salt using this method and the distribution of EC (1:5) values shown in Fig. 4. The detection limit depth for the infiltrating salinity (i.e., the depth at which salinity no longer changed significantly) was around 37 cm (Fig. 4). We therefore performed our calculations to a depth of 37 cm. The amount of salinity for each unit area (to this depth) equaled 0.46 g cm⁻², and the corresponding amount of water required was between 1,687 and 1,993 mm. It is possible to use these values to roughly estimate the thickness of surface soil that must be removed to achieve sufficient salt removal. Figure 9 shows the relationship between the thickness of removed

surface soil and the amount of rainfall required for salt removal. If the total amount of rainfall after a tsunami is known, the thickness of surface saline soil that must be removed to achieve sufficient salt removal can be estimated from this figure.

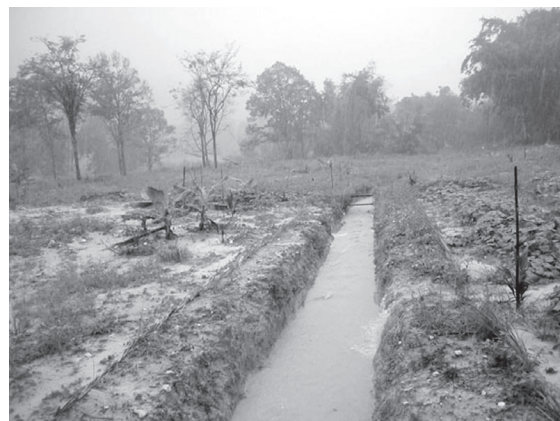
Fig. 10. Example of a small drainage ditch that has been dug near Bang Niang to enhance salt removal through drainage

After the surface saline soil has been removed, the leaching effect can be enhanced by creating small drainage ditches that carry away drainage water more efficiently (Fig. 10). Note that this approach will work best in areas where the water flow is primarily horizontal, as in our study area; in areas where deep infiltration occurs quickly, the method may have to be modified to account for migration of salt into deeper soil layers.
