REVIEW

Action Program for Small-scale Riverbank Protection in a Bangladesh Village

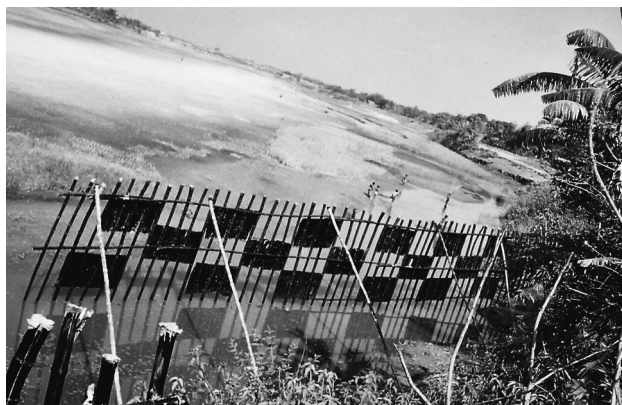
Photo 1. Palisade in the Lowhajan River (May 1994)

The final design was decided as follows: a four-sided fence constructed out of bamboo tied vertically and horizontally in a checker pattern and iron boards made from stretched out oil drums (Photo 1). The size of each iron board is 0.6 m×1.2 m, the standing bamboo is placed 0.3 m apart, and two bamboo lines are placed horizontally 1m apart. The standing bamboo is installed at 1.5 m depth in the riverbed, and supported by the same materials at 3 m intervals at an angle to the riverside.

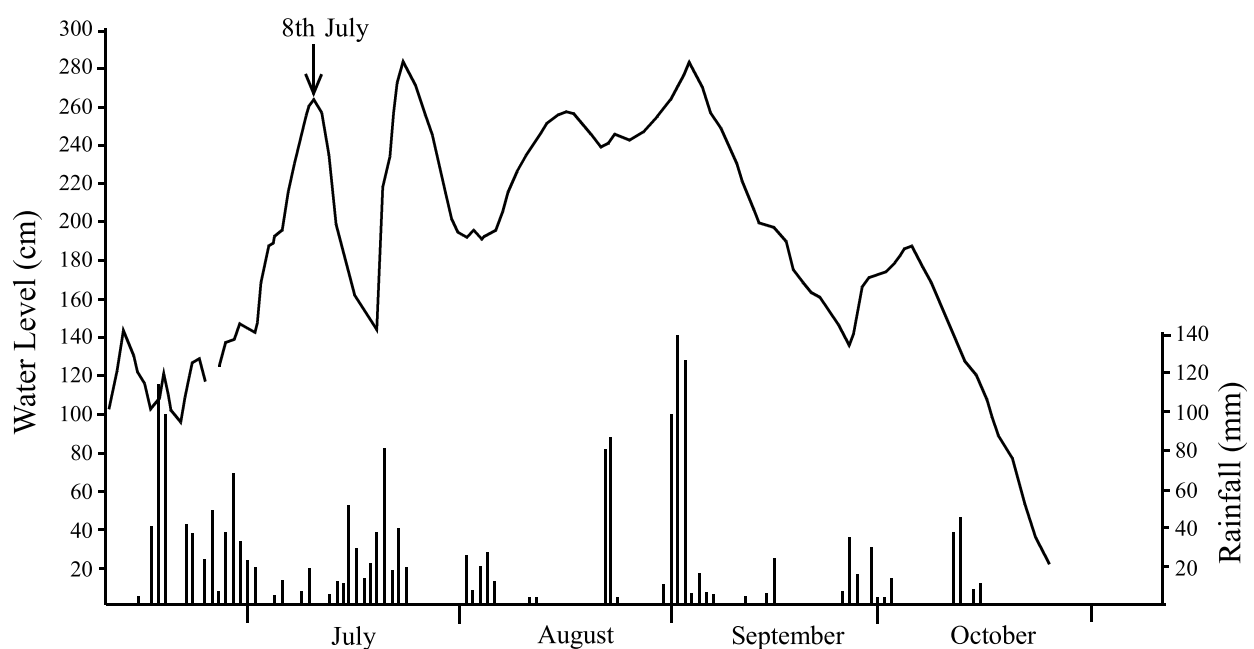
Fig. 4. Water level of the Lowhajon River in the rainy season (1993)

Table 2 shows the problems for palisades. The short-side of Palisade (1) had been washed away July 8, 1993, in the rainy season. As shown in Fig. 4, the quantity of precipitation was less than 20 mm at the time, but the water level was higher because of the preceding rainfall. In 1994, only the longer-side of the palisade was repaired and located at the same site as the previous year. Rising water levels loosened the knots of the lower part of the palisade and an engine boat crashed into its center, causing part of it to be lost, on the night of August 22. The lower part of Palisade (2) was washed away. One reason is that the knots were loosened by high waves caused by engine boats. Another reason is that this new palisade had not been installed deeply when it had been constructed.
