Prediction of Inundation Areas Due to Failure in Small Earthfill Dam Using Numerical Analysis

Daisuke SHODA*, Osamu KAWAMOTO, Hiroshi YOSHISAKO and Keisuke INOUE

Facilities and Geotechnical Engineering Research Division, National Institute for Rural Engineering, National Agriculture and Food Research Organization (NARO) (Tsukuba, Ibaraki 305-8609, Japan)

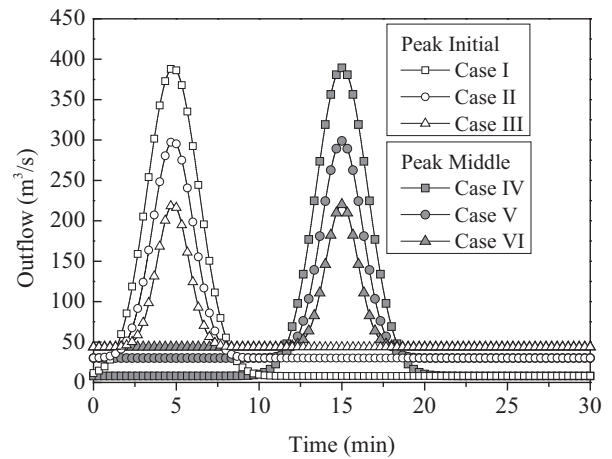
Fig. 2. Hydrograph at outflow point

where Q_{max} is the peak outflow per second, Q_{base} is the initial outflow per second, t is time, t_p is peak time, and $T_{3/4}$ is time at three-quarters of the water level. The hydrograph at the outflow point is shown in Fig. 2. Total outflow time is 30 min, as determined from interviews. Time at peak outflow (t_p) refers to “initial” and “middle” cases during the total outflow time (30 min) to compare water depth in the downstream area. Time at peak outflow for the initial case is 4.8 minutes and 15 minutes for the middle case.
