Farmland reclamation using micro-dam sediments in the Ethiopian Highlands

(K. Koda, G. Girmay [Mekelle University], T. Berihu [Mekelle University])

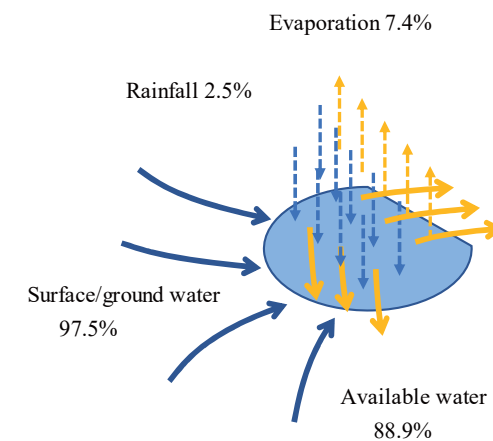
Fig. 1. Water balance of Adizaboy micro-dam
The storage volume of the micro-dam is 200,000m³. Available water is assumed to be the sum of water leakage through the foundation rock and the embankment, the flood water over the spillway, and the spring water downstream.

The Adizaboy micro-dam is located at the outlet of the steep Adizaboy micro-watershed (8.5 km²). Weather conditions and water depths in Adizaboy micro-dam were automatically recorded. The storage volume change was assumed to be zero (0) for one year. Potential available water was calculated using the water balance analysis of Adizaboy micro-dam (Fig. 1). A new bathymetric survey method was applied to estimate the sediment volume in the micro-dam. The geographic coordinates along the water surface perimeters and the storage water depths were noted (Fig. 2, top). Sediment volume between observed sediment surface and estimated bottom surface was calculated (Fig. 2, bottom). Bare lands were cleared at the end of dry season (an agricultural off-season), when there was no storage water in the micro-dam. Sediments were excavated manually and transported using farm animals. A farmland was reclaimed by forming layers of stones and sediments (Fig. 3).

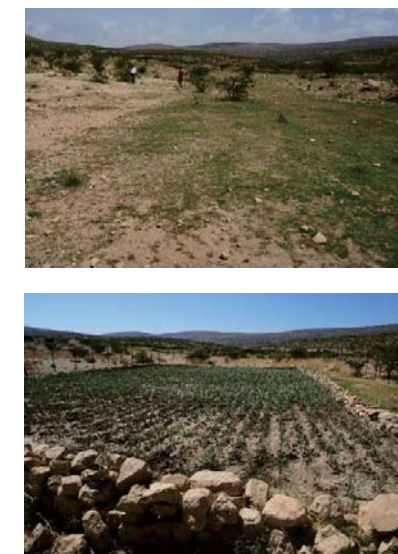
Fig. 3. The reclaimed farmland using sediments from Adizaboy micro-dam
Top: before reclamation, Bottom: after reclamation

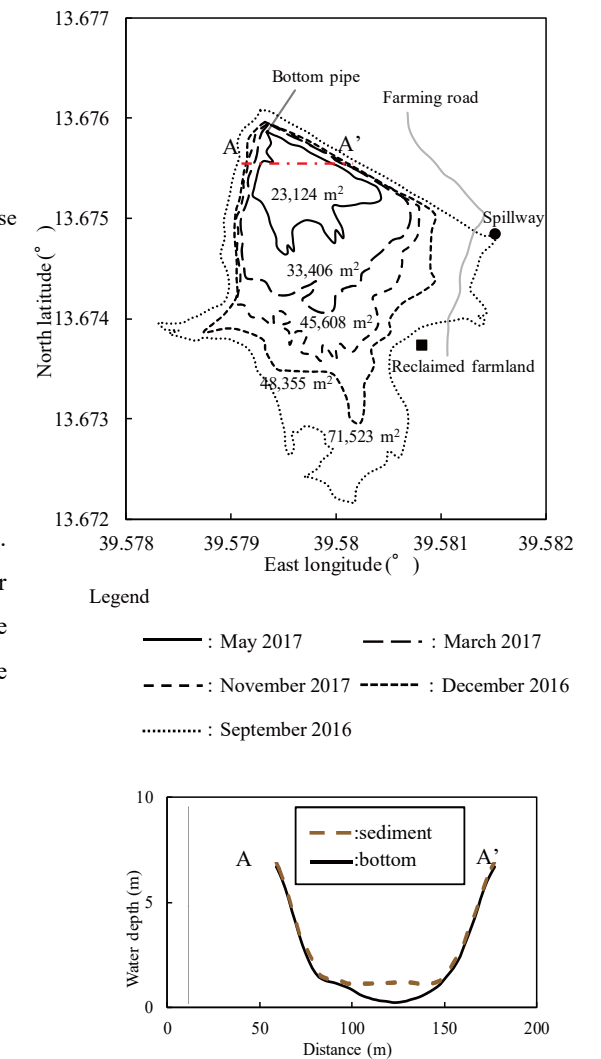
Fig. 2. Changes in water storage area and cross-sectional view of Adizaboy micro-dam
Top: changes in water storage area, Bottom: cross sectional view

The numbers in the top figure show the water storage areas (in m²). The water depth in the bottom figure displays the height from the lower edge of the bottom pipe inlet. The sediment volume of Adizaboy micro-dam is estimated to be 6,400 m³. In case the thickness of the reclaimed farmland is 0.2 m, the reclaimable farmland area is 3.2 ha. It would also be effective if some of the sediments are removed and used for reclamation before the bottom pipe gets buried and malfunctions.
